## Service Information No. 27/2010

# Replacing air filter element

F 650 GS (K72, 0218/0228), F 800 GS (K72,

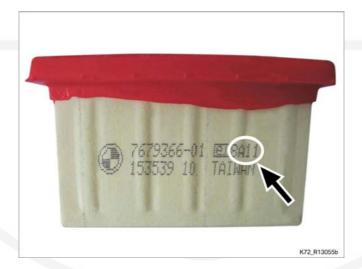
Each air filter element bears the production date in coded form (see photo).

Example: "8A11" stands for 2008, January 11 (so in this case the air filter element is not from the period during the production process was faulty):

- 8 = Production year 2008
- A = Production month January (A = January, B = February, ..., L = November,
   M = December (I is not used: J = September))
- 11 = Day of manufacture in production month

Photo: Air filter element with coded production date

Each air filter element that has to be replaced bears one of the following codes: 9B16, 9B26, 9C05, 9C12, 9C19, 9C24, 9D01, 9D08, 9D15, 9D27, 9D28, 9E06, 9E19, 9E25, 9E27, 9F11, 9G01, 9G03, 9G06, 9G07, 9G14, 9G21, 9G22, 9G29, 9H06, 9H12, 9H19, 9J01, 9J07, 9J11, 9J14, 9J16, 9J29, 9K05, 9K12, 9K29, 9L24.

Before handing over a new motorcycle to its owner or when motorcycles possibly affected by this problem are next brought to the workshop, replace the air filter element (see attached work item 00 60 654 for details).
